# The Dynamic Development of the Sebou Valley and Its Impact on the River Domain Between Oued Inaouene and Oued Bouchabel (Pre-Rif) Morocco

**Abstract:** In this paper, we present the study's results of the fluvial erosion aspects in the Sebou valley, between River Inaouene and River Bouchabel in the Pre-Rif mountains. On the one hand, we analyzed the hydrodynamic factors interfering in the erosion, and on the other hand, we studied the types of banks exposed to the fluvial erosion processes and the degree of their deterioration. In order to achieve our objectives, this research was based on observation and interviews with the local population, fluvial erosion measurements, literature reviews, and the adoption of statistical series of precipitation and water flow for the Dar Al-Arsa station. As results, we found that despite the presence of the Allal El Fassi dam in the upstream of Sebou valley and the presence of the Idris I dam in the upstream of Inaouene valley, the water flow of Sebou between the Inaouene valley and the Bouchabel valley is characterized by important flood periods that erode the river banks, where the maximum flow in the studied field exceeds 400 m<sup>3</sup>/

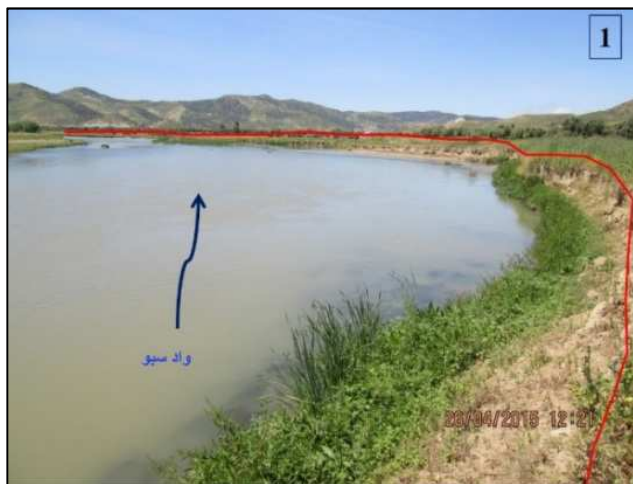
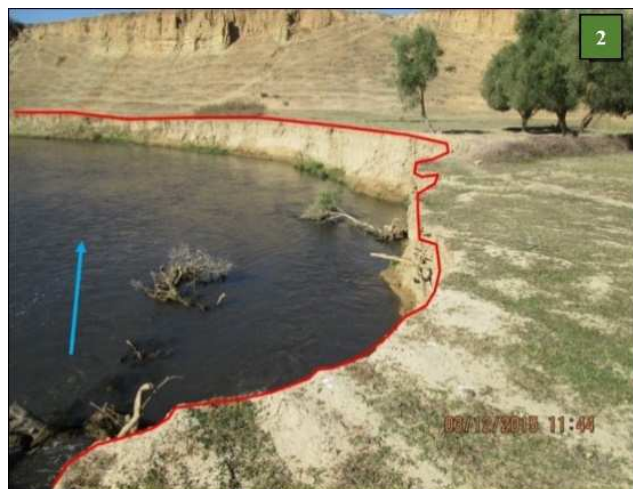
River banks are subject to strong lateral erosion due to the water current during eruptions, making the course of the stream in a continuous development, especially at the bottom of the curves, as shown in Figure 6, this provides examples of cases of bank erosion [2, 3, 6, 13, 14], as they are located in places faced with the water current, especially in the high flow stages, due to the fragility of the bank components and their low resistance to erosion, despite the presence of vegetation cover in some places.

1) - Bank erosion east of Zkara

2) - Bank erosion southwest of Ouled Zen

**Figure 6.** Examples of lateral erosion in some banks of the Sebou River stream.

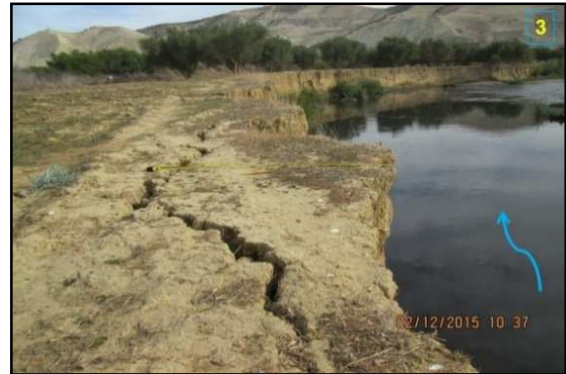
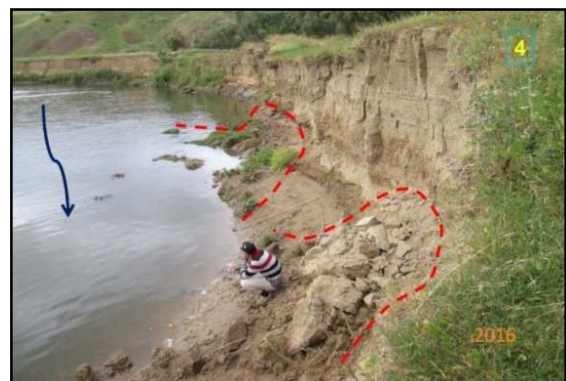
The strength and danger of fluvial erosion increases as we move from top to bottom, as a result, most of the banks are subject to collapse, as shown in the images of panel 2 in image 1 on the north right bank, northeast of Douar Ouled El Yamani area, at the beginning of the concavity, This entire bank collapsed, following the digging at its feet, and Figure 7 west of Douar Megra area shows that the bank collapsed for about 2.5 km on the north right bank, it appears that the latter is constantly collapsing, despite being parallel to the water current and despite its plant cover availability.

3) - The collapse of the banks, South of Douar Ouled El Yamani

4) - North of the Megra douar (view from the northeast)

**Figure 7.** Some models of bank collapse in the studied course.
